The Technical Challenges of Exploration and Excavation at the Money Pit, Oak Island, Nova Scotia

Presentation by
Les MacPhie
SNC-Lavalin Inc., Montreal
to
Independent Activities
Period 2008
Massachusetts Institute of
Technology
Cambridge, MA
January 28, 2008

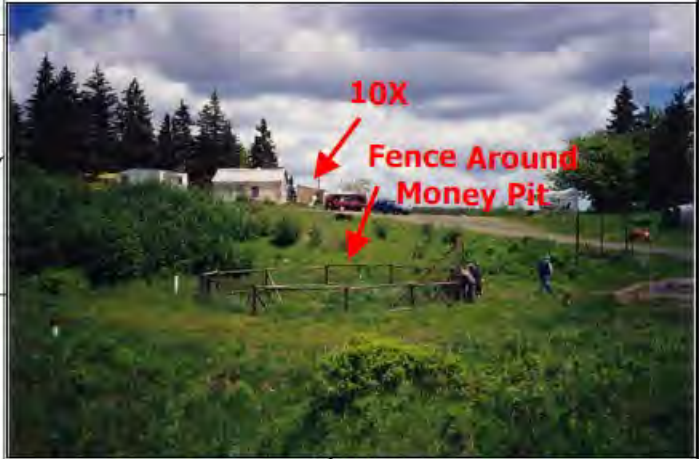
Plan of Exploration Boreholes

1. Becker Drilling 1967

2. Warnock Hersey 1969

3. Golder Associates 1970

4. Detection Program Drilling 1993
